Staveley and Copgrove P C

Play Area Inspection

Inspected by Park Lane Playgrounds

13th June 2018 at 11.00am

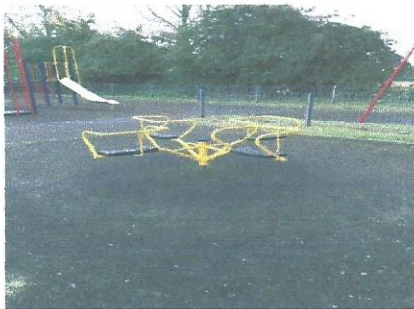
Unit: Wicksteed Whirly Bird
Year of Manufacture: 2000
Overall Condition: Good
Comments: Wet pour surface showing signs of wear
 Debris on the surface

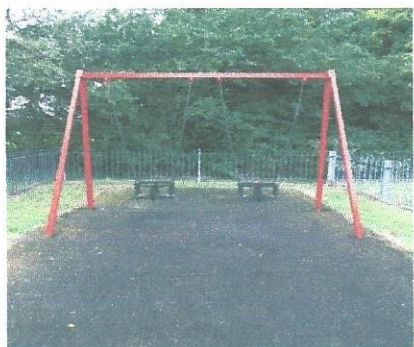
Unit: Record Cradle Swings
Year of Manufacture: Unknown
Overall Condition: Good
Comments: Bird excrement on the seats and surface
 Crack in the wetpour surface

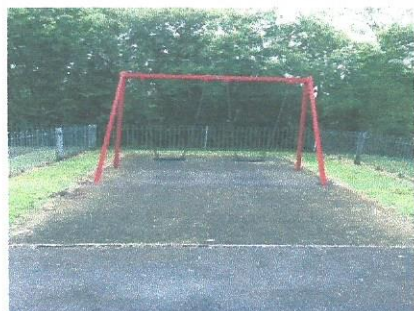
Unit: Record Flat Seat Swings
Year of Manufacture: Unknown
Overall Condition: Good
Comments: Bird excrement on the seats and the wetpour surface

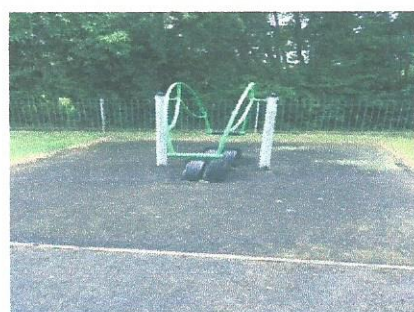
Unit: Hags Multi Pondo
Year of Manufacture: 2000
Overall Condition: Good
Comments: Rubber missing on the footrest
 Damage to the rubber
 Debris and weeds on the surface

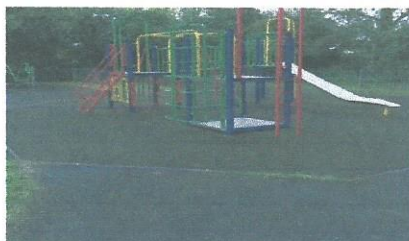
Unit: Play and Leisure Multi Unit
Year of Manufacture: 2000

Overall Condition: Good
Comments: Chains showing signs of wear
Debris and weeds on the surface

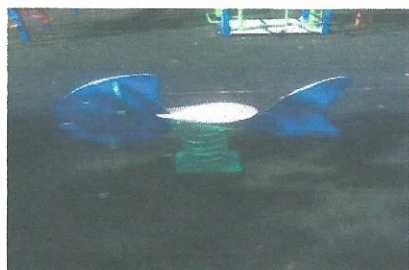
Unit: Play and Leisure Fish Spring Mobile
Year of Manufacture: 2006
Overall Condition: Good
Comments:

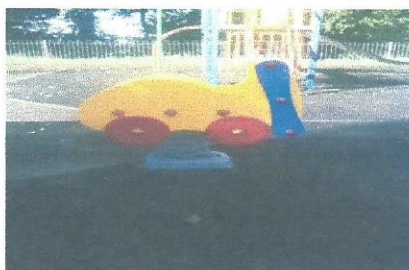
Unit: Ledon Car Spring Mobile
Year of Manufacture: 2002
Overall Condition: Good
Comments:

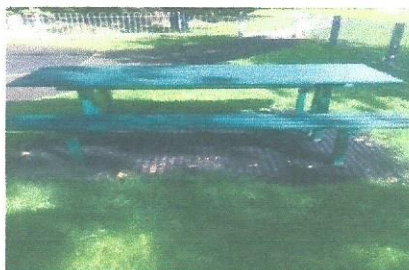
Unit: Bench
Year of Manufacture: Unknown
Overall Condition: Good
Comments:

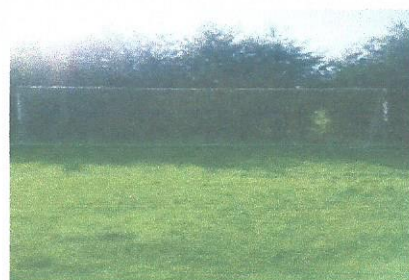
Unit: Goalposts
Year of Manufacture: Unknown
Overall Condition: Average
Comments: Moles hills on the area
Grass requires cutting
(See Appendix A)

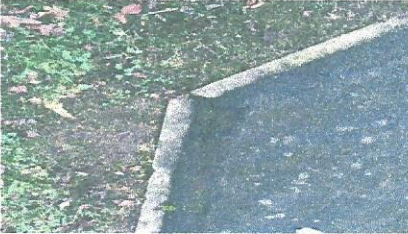
Whirley bird

Wet pour showing signs of wear

Monitor the wet pour until the next inspection

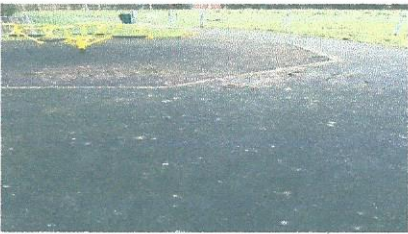
Debris on the area

Remove the debris

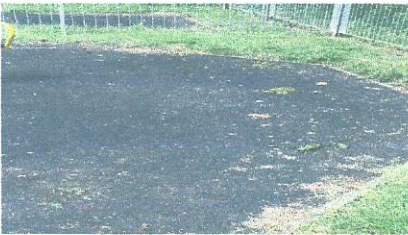
Debris and grass on the surface

Remove the grass and debris to prolong the life of
the wetpour

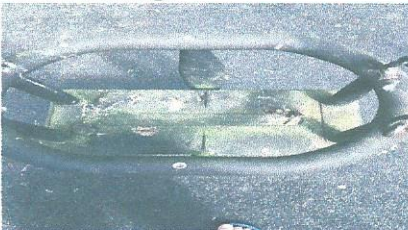
Cradle Swings

Bird excrement on the seat and surface

Remove the excrement

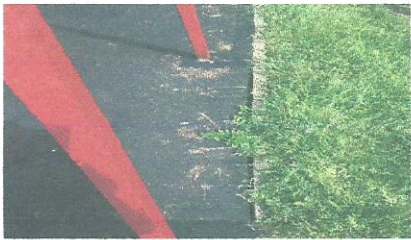
Crack in the wet pour surface

Monitor the crack until the next inspection

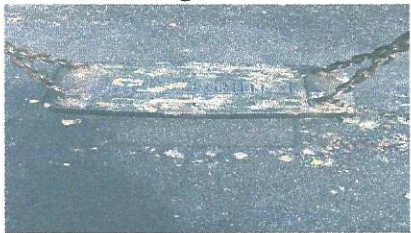
Flat Seat swings

Bird excrement on the seats and surface

Remove the excrement

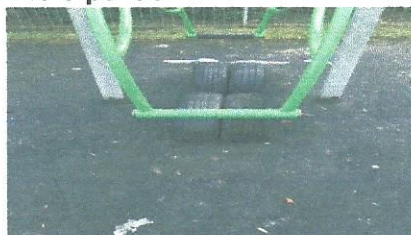
Multi pondo

Rubber footrest missing

Replace the rubber

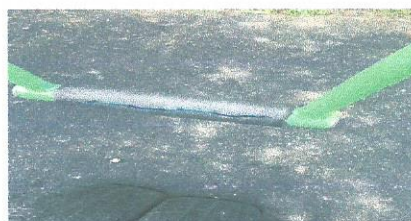
rubber damaged

Remove the rubber and replace

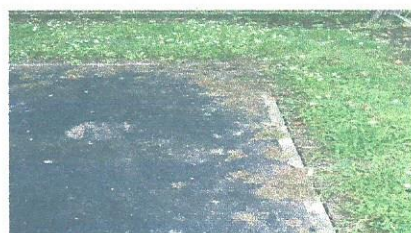
Debris and grass on the surface

Remove the debris and grass to prolong the life

of the wetpour surface

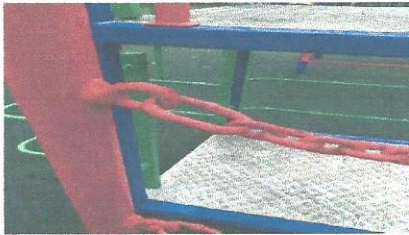
Multi Unit

Chains showing signs of wear

Monitor chains until next inspection

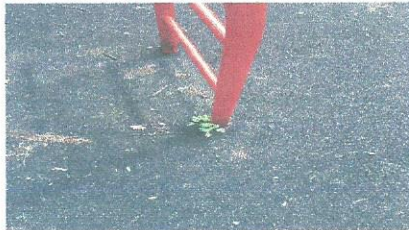
Weeds and debris on the area

Remove the debris and weeds

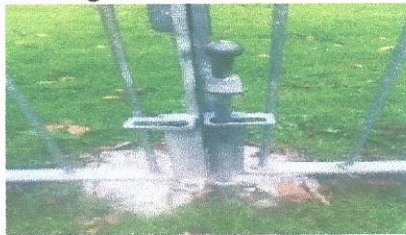
Fencing and Gates

Drop pin missing on vehicular Access Gate
No Padlock

Replace Drop pin
Replace the padlock

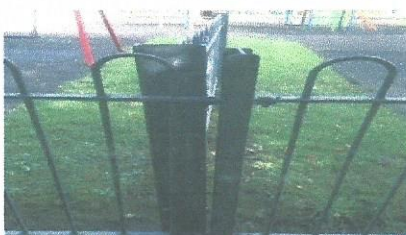
1 no post loose in ground

Secure loose post

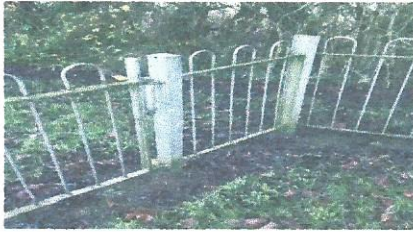
Moss on pedestrian gate and fencing

Remove moss from fencing and gate

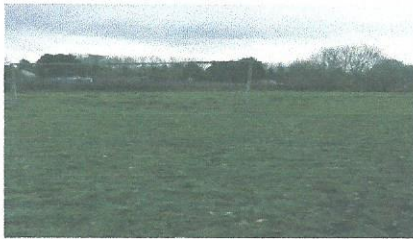
Mole hills on the area

Remove the mole hills

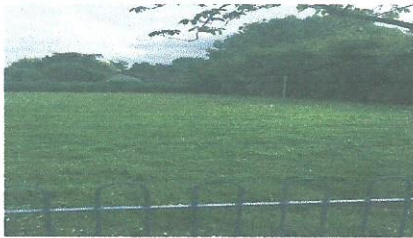
Over grown grass

Cut the grass inside and outside the area.
