# PLAY AREA SAFETY INSPECTION REPORT

Site Owner : **Parish Councils**  
Site Name : Staveley Play Area  
Date of Inspection : 22 September 2017  
Inspected by : David Owen

The present overall risk rating for the play space is **MEDIUM**

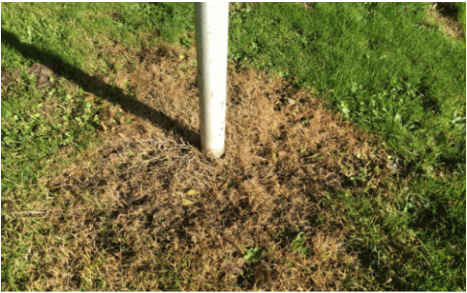
Comments, action or control required		Risk Level	Risk Score ‡
<b>Equipment</b>			
Finding :	Item - Loose in Ground	Low	5
Notes :	Foundations loose on both goals - reset.

Task :	Secure and make stable main frame and supports		
<b>Surfacing - Grass</b>			
No remedial maintenance work is required at this time.			
<b>The overall risk for this item at the time of inspection:</b>		Medium	8
‡ For Risk Score see Report Notes

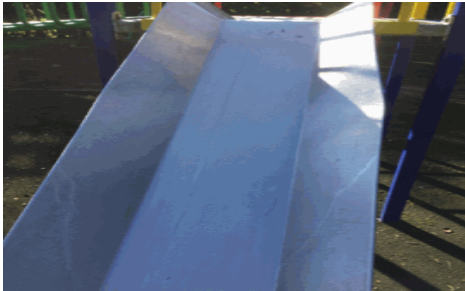
Comments, action or control required		Risk Level	Risk Score ‡
<b>Equipment</b>			
Finding :	Item - Bent	Low	4
Notes :	Chute - monitor, try to straighten.

Task :	Repair item		
Finding :	The spacing between the barrier bars is in excess of 89 mm	Very Low	3
Finding Date :	22/09/2017		
Notes :	Between barriers on slide, step, overhead and arch access points.

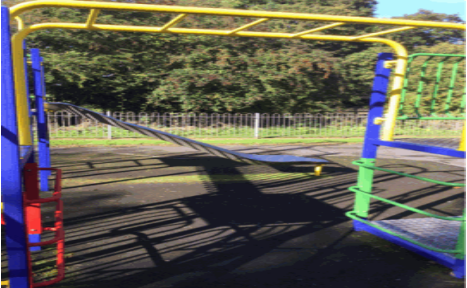
<p>Finding : RoSPA is concerned by accidents on some types of overhead ladders and rings . There is, however, a strong development value in these items.</p> <p>Finding Date : 22/09/2017</p>

<p>Task : The protective surface under all bars and rings must be kept in good condition.</p>	<p>Low</p>	<p>5</p>
<p><b>Surfacing - Wet Pour</b></p>		
<p>Finding : Surface - Moss</p> <p>Notes : Slippery surface - clean surface regularly due to trees.</p>

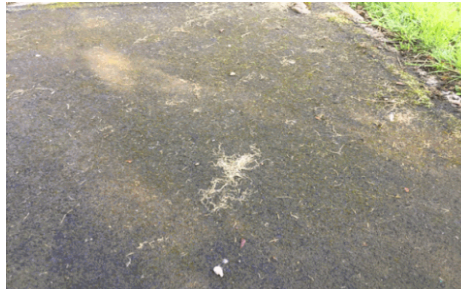
Comments, action or control required		Risk Level	Risk Score ‡
<b>Equipment</b>	No remedial maintenance work is required at this time.		
<b>Surfacing - Wet Pour</b>			
Finding :	Surface - Moss	Low	6
Notes :	Slippery surface - clean surface regularly due to trees.		
Task :	Remove		
<b>The overall risk for this item at the time of inspection:</b> ‡ For Risk Score see Report Notes		Low	6

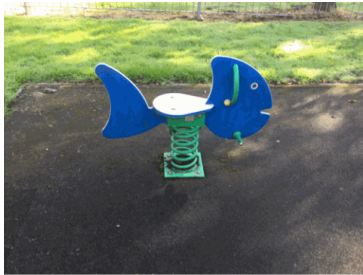
Comments, action or control required		Risk Level	Risk Score ‡
<b>Equipment</b>			
Finding :	Protruding handles/footrests	Very Low	3
Notes :	Ring probe test - no action required.		
Task :	No Action Required

<b>Surfacing - Wet Pour</b>			
Finding :	Surface - Moss	Low	6
Notes :	Slippery surface - clean surface regularly due to trees.		
Task :	Remove

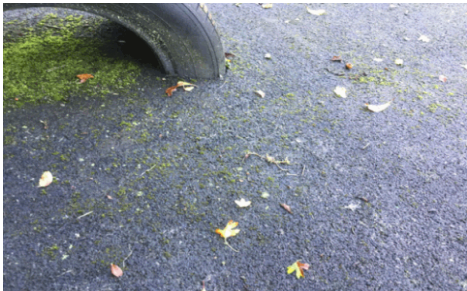
Comments, action or control required	Risk Level	Risk Score ‡
<b>Equipment</b> No remedial maintenance work is required at this time.		
<b>Surfacing - Wet Pour</b>		
Finding : Surface - Moss  Finding Date : 22/09/2017 Notes : Slippery surface - clean surface regularly due to trees.

Low	6
Task : Remove		
<b>The overall risk for this item at the time of inspection:</b> ‡ For Risk Score see Report Notes		Low
		6

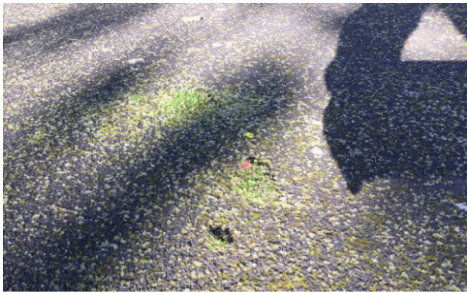
Comments, action or control required		Risk Level	Risk Score ‡
<b>Equipment</b> No remedial maintenance work is required at this time.			
<b>Surfacing - Wet Pour</b>			
Finding : Surface - Moss

Low	4
Finding Date : 22/09/2017			
Notes : Clean surface regularly due to trees.			
Task : Remove			
<b>The overall risk for this item at the time of inspection:</b> ‡ For Risk Score see Report Notes		Low	5

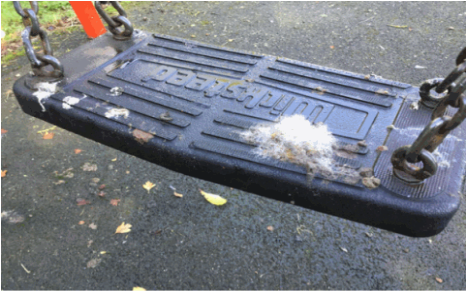
Comments, action or control required		Risk Level	Risk Score ‡
<b>Equipment</b>			
<p>Finding : Bird fouling present</p> <p>Finding Date : 22/09/2017</p> <p>Notes : Children will not be able to use the swing in this condition. Our inspector recommends you install anti-bird ties to the top bar.</p>

<p>Task : It is recommended that play equipment is regularly checked for bird fouling- If found the affected items should be cleaned with a disinfectant solution</p>	Medium	8	
<b>Surfacing - Wet Pour</b>			
<p>Finding : Surface - Moss</p> <p>Finding Date : 22/09/2017</p> <p>Notes : Slippery surface - clean surface regularly due to trees.</p>

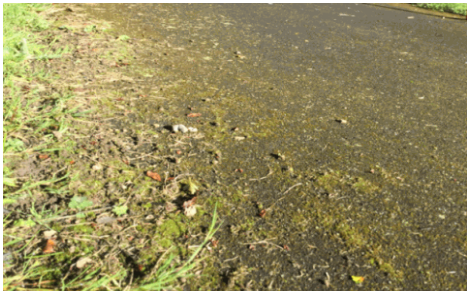
Comments, action or control required	Risk Level	Risk Score ‡
<b>Equipment</b> No remedial maintenance work is required at this time.		
<b>Surfacing - Wet Pour</b>		
Finding : Surface - Moss  Finding Date : 22/09/2017 Notes : Slippery surface - clean surface regularly due to trees.

Task : Remove	Low	6
<b>The overall risk for this item at the time of inspection:</b> ‡ For Risk Score see Report Notes	LOW	6
