# Staveley and Copgrove P C

## Play Area Inspection

Inspected by Park Lane Playgrounds

1st March 2017 at 2.00PM

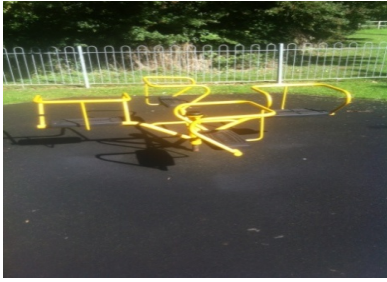
**Unit:** Wicksteed Whirly Bird  
**Year of Manufacture:** 2000  
**Overall Condition:** Good  
**Comments:** Paintwork showing signs of wear  
Moss on safety surface  
**( See Appendix A )**  
**Surfacing:** Wetpour

**Recommendation:**  
Monitor until next inspection

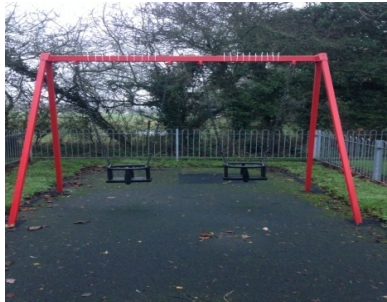
**Unit:** Record Cradle Swings  
**Year of Manufacture:** Unknown  
**Overall Condition:** Good  
**Comments:** cable ties do not  
comply with BS EN1176 standards  
Moss on the seats and surface  
Lubricate the bushes and shackles  
**( See Appendix A )**  
**Surfacing:** Wetpour  
Crack in the wetpour monitor until the  
next inspection

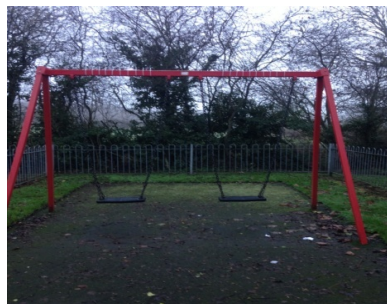
**Unit:** Record Flat Seat Swings  
**Year of Manufacture:** Unknown  
**Overall Condition:** Good  
**Comments:** cable ties do not comply with  
BS EN1176 standards  
Moss and debris on the safety surface  
Mole hills around the edge of the surface  
**(See Appendix A)**  
**Surfacing:** Wetpour

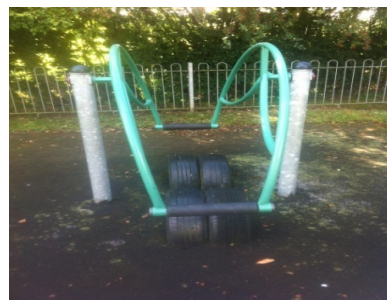
**Unit:** Hags Multi Pondo  
**Year of Manufacture:** 2000  
**Overall Condition:** Good  
**Comments:** Moss on the safety surface  
**Surfacing:** Wetpour

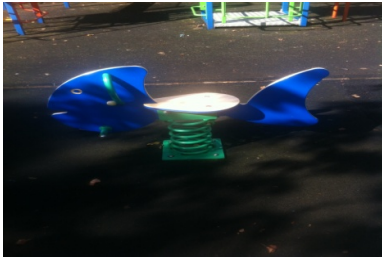
Unit: Play and Leisure Fish Spring Mobile

Comments: Moss on the safety surface

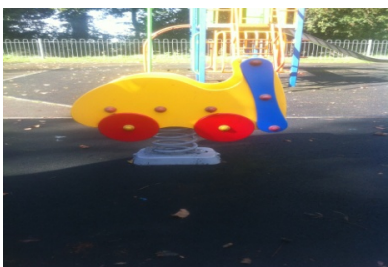
Unit: Ledon Car Spring Mobile

Comments: Moss on safety surface, clamps showing signs of wear

Monitor the clamps until the next inspection

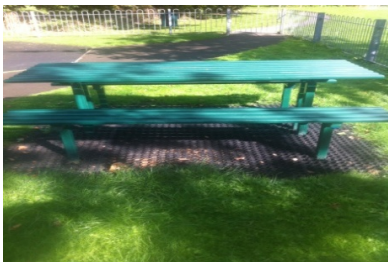
Unit: Bench

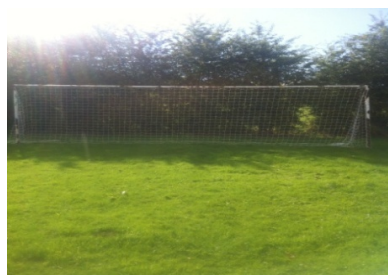
Unit: Goalposts

Overall Condition: Average

Comments: Both goals slightly loose in ground-monitor until next inspection

Moles hills on the area

**Recommendations:**  
Remove the mole hills

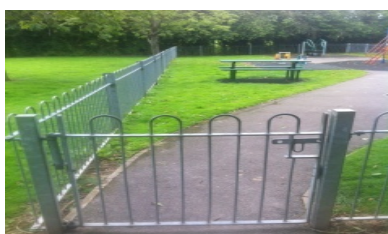
Unit: Fencing and Gates

Overall condition: Average

Comments: Drop Pin Missing on Vehicle Access Gate  
1 no post loose in ground, moss on fence and pedestrian gate.

**Recommendation:**  
Replace Drop pin

**Recommendation:**  
Secure loose post

**Recommendation:**  
Remove moss from fencing and gate

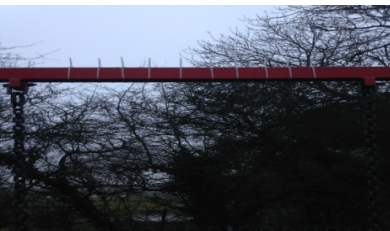
### Cradle Swings

**Comments:**  
Cable ties do not comply with BS EN1176 standards

**Recommendation:**  
Monitor cable ties for any sharp edges

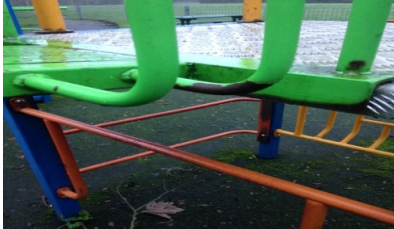
**Multi Unit**

Paint corrosion

Sand down and re-paint that complies with EN1176.4.1.1 standard.

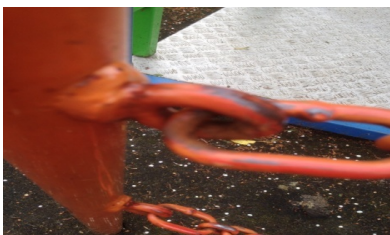
Chains showing signs of wear

Monitor chains until next inspection

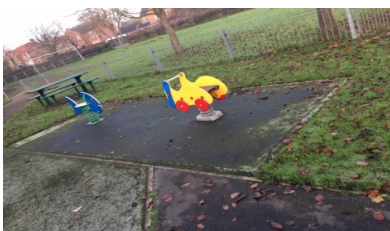
Moss on the surface

Remove the moss
