Staveley and Copgrove P C

Play Area Inspection

Inspected by Park Lane Playgrounds

1st September 2017 at 3.00pm

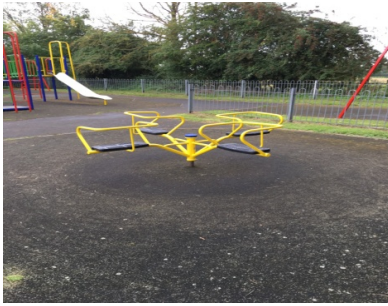
Unit: Wicksteed Whirly Bird
Year of Manufacture: 2000
Overall Condition: Good
Comments: Moss and weeds on safety surface
Wet pour surface showing signs of wear

(See Appendix A)
Surfacing: Wetpour

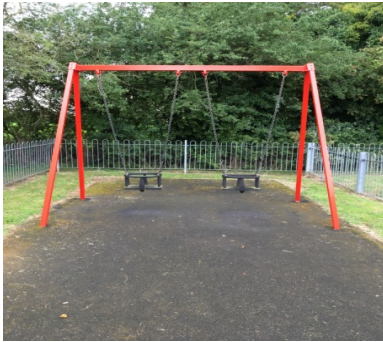
Unit: Record Cradle Swings
Year of Manufacture: Unknown
Overall Condition: Good
Comments: Moss on the seats and surface

(See Appendix A)
Surfacing: Wetpour
Crack in the wetpour, repair to prevent any further deterioration.

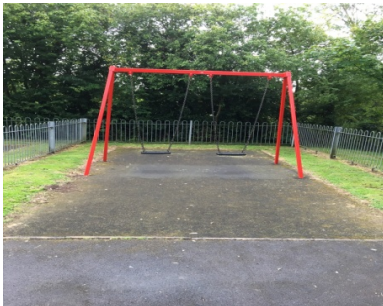
Unit: Record Flat Seat Swings
Year of Manufacture: Unknown
Overall Condition: Good
Comments: Moss and debris on the safety surface

(See Appendix A)
Surfacing: Wetpour

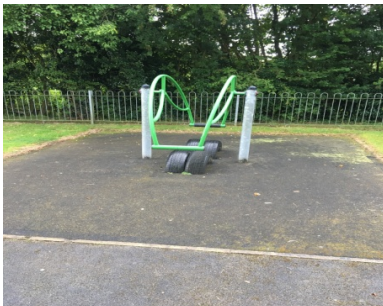
Unit: Hags Multi Pondo
Year of Manufacture: 2000
Overall Condition: Good
Comments: Moss on the safety surface

Surfacing: Wetpour

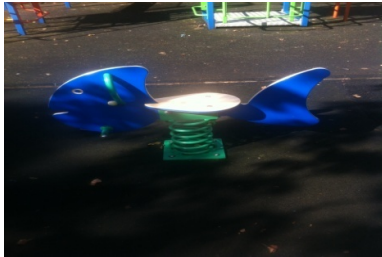
Unit: Play and Leisure Fish Spring Mobile
Year of Manufacture: 2006
Overall Condition: Good
Comments: Moss on the safety surface

Surfacing: Wetpour

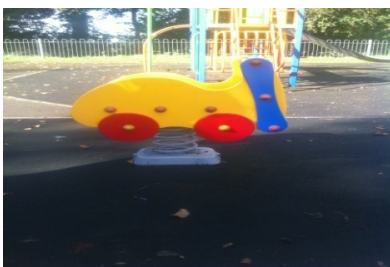
Unit: Ledon Car Spring Mobile
Year of Manufacture: 2002
Overall Condition: Good
Comments: Moss on safety surface,
Replace the clamp
(See Appendix A)

Surfacing: Wetpour

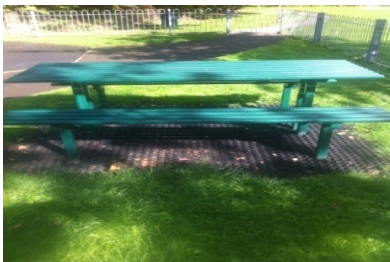
Unit: Bench
Year of Manufacture: Unknown
Overall Condition: Good
Comments:

Surfacing: Rubber Grassmat

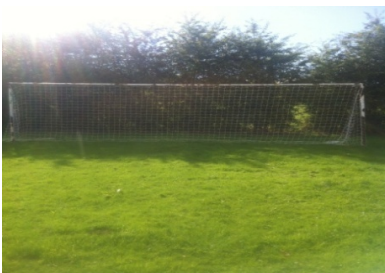
Unit: Goalposts
Year of Manufacture: Unknown
Overall Condition: Average
Comments: Both goals slightly loose in ground-monitor
until next inspection
Moles hills on the area
(See Appendix A)

Surfacing: Grass

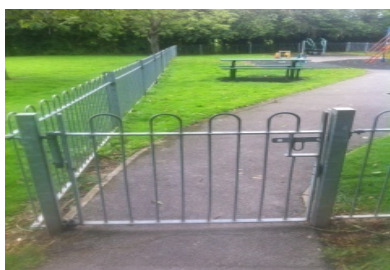
Unit: Fencing and Gates
Year of Manufacture: Unknown
Overall condition: Average
Comments: Drop Pin Missing on Vehicle Access Gate
1 no post loose in ground, moss on fence
and pedestrian gate.
The bottom crook is coming out on

the timber gate, 1 gate not closing
gate
(See Appendix A)

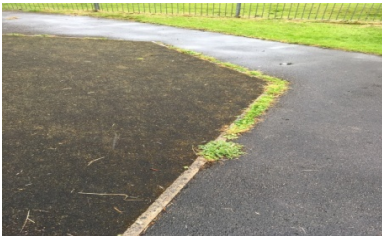
Weeds and moss on the surface

Remove the moss and weeds

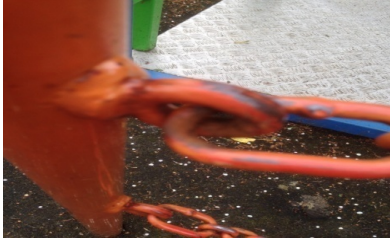
Multi Unit

Chains showing signs of wear

Monitor chains until next inspection
