# Staveley and Copgrove P C

## Play Area Inspection

**Inspected by Park Lane Playgrounds**

**5th December 2016 at 2.50pm**

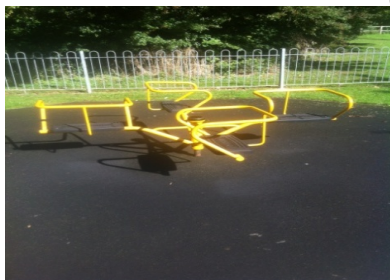
Unit: Wicksteed Whirly Bird  
 Year of Manufacture: 2000  
 Overall Condition: Good  
 Comments: Paintwork showing signs of wear  
 Moss on safety surface  
 ( See Appendix A)  
 Surfacing: Wetpour

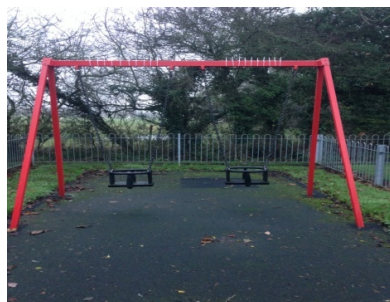
Unit: Record Cradle Swings  
 Year of Manufacture: Unknown  
 Overall Condition: Good  
 Comments: cable ties do not  
 comply with BS EN1176 standards  
 Moss on the seats and surface  
 ( See Appendix A)  
 Surfacing: Wetpour

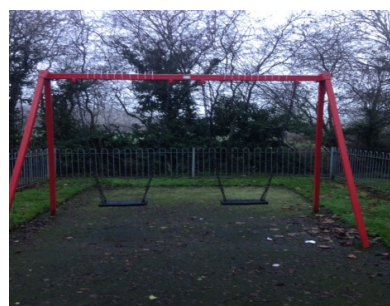
Unit: Record Flat Seat Swings  
 Year of Manufacture: Unknown  
 Overall Condition: Good  
 Comments: cable ties do not comply with  
 BS EN1176 standards  
 Moss on the safety surface  
 (See Appendix A)  
 Surfacing: Wetpour

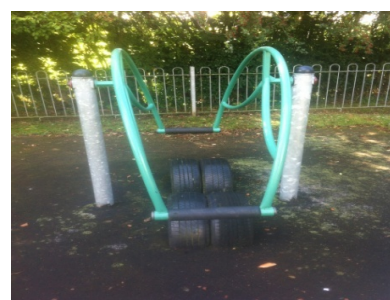
Unit: Hags Multi Pondo  
 Year of Manufacture: 2000  
 Overall Condition: Good  
 Comments: Moss on the safety surface  
 Surfacing: Wetpour

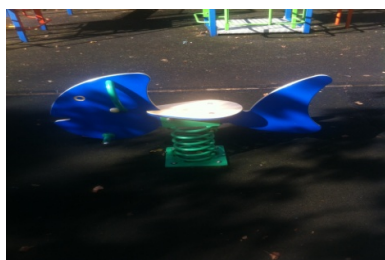
Unit:

Play and Leisure Fish Spring Mobile

Comments: Moss on the safety surface

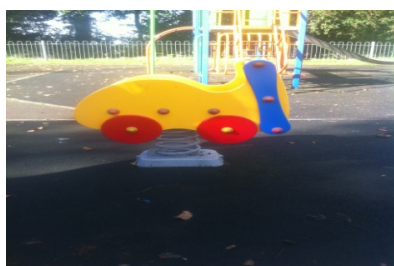
Unit:

Ledon Car Spring Mobile

Comments: Moss on safety surface, clamps showing signs of wear

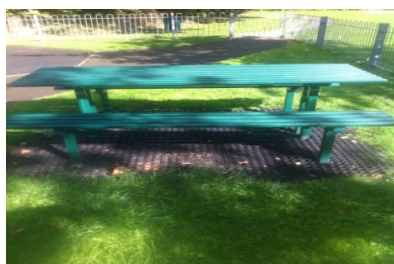
Unit:

Bench

Comments:

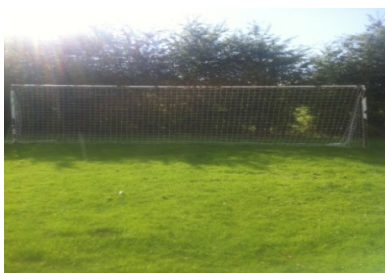
Unit:

Goalposts

Comments: Both goals slightly loose in ground-monitor until next inspection

Moles hills on the area

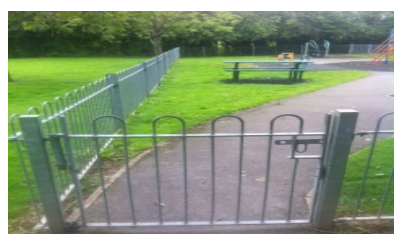
Unit:

Fencing and Gates

Comments: Drop Pin Missing on Vehicle Access Gate

1 no post loose in ground, moss on fence and pedestrian gate.

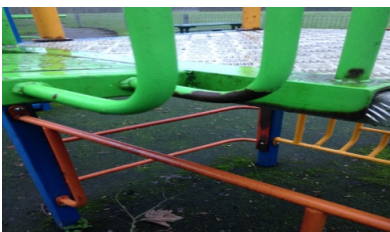
### Multi Unit

Paint corrosion

Sand down and re-paint that complies with EN1176.4.1.1 standard.

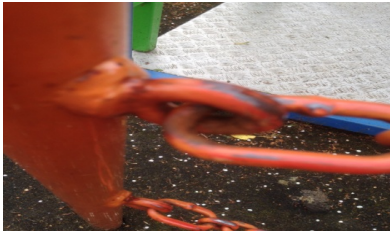
**Comments:**  
Chains showing signs of wear

**Recommendation:**  
Monitor chains until next inspection

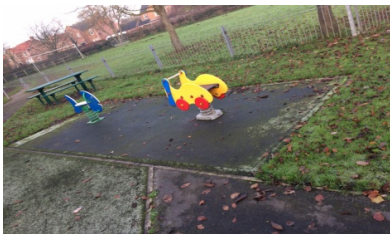
**Comments:**  
Moss on the surface

**Recommendations:**  
Remove the moss

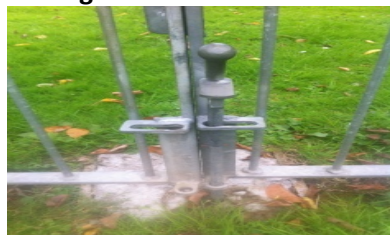
### Fencing and Gates

**Comments:**  
Drop pin missing on vehicular Access Gate

**Recommendation:**  
Replace Drop pin

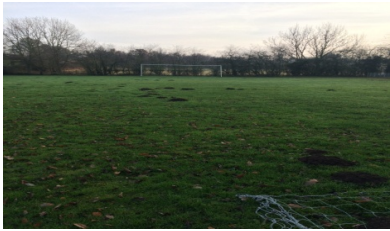
Mole hills on the area

Remove the mole hills
