# Staveley and Copgrove P C

## Play Area Inspection

**Inspected by Park Lane Playgrounds**

**9th March 2016 3.45PM**

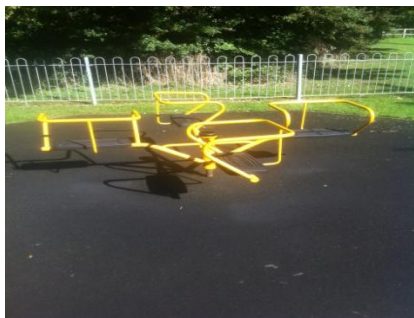
**Unit:** Wicksteed Whirly Bird  
**Year of Manufacture:** 2000  
**Overall Condition:** Good  
**Comments:** Weed growth, moss and debris on area,  
 Paintwork showing signs of wear  
**( See Appendix A)**

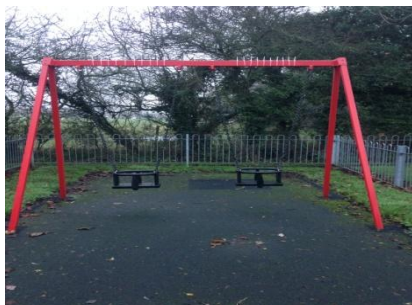
**Unit:** Record Cradle Swings  
**Year of Manufacture:** Unknown  
**Overall Condition:** Good  
**Comments:** Bushes require lubricating, moss on seats,  
 moss and debris on area, cable ties do not  
 comply with BS EN1176 standards  
 There are several mole hills  
**( See Appendix A)**

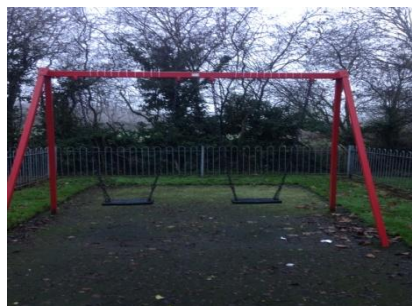
**Unit:** Record Flat Seat Swings  
**Year of Manufacture:** Unknown  
**Overall Condition:** Good  
**Comments:** Bushes require lubricating, moss and debris  
 on area, cable ties do not comply with  
 BS EN1176 standards  
**(See Appendix A)**

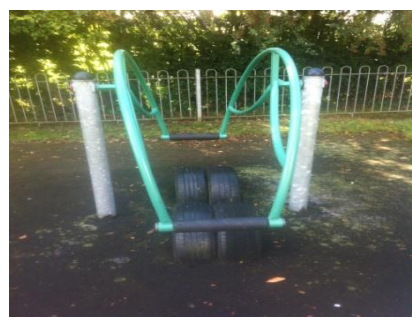
**Unit:** Hags Multi Pondo  
**Year of Manufacture:** 2000  
**Overall Condition:** Good  
**Comments:** Damage to safety surface, moss and debris  
 on area.  
**(See Appendix A)**

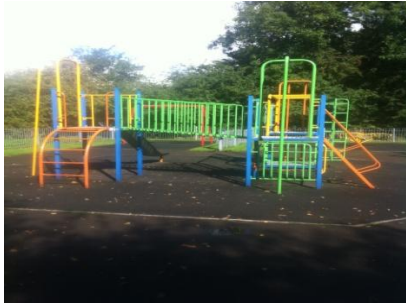
**Unit:** Play and Leisure Multi Unit  
**Year of Manufacture:** 2000  
**Overall Condition:** Good  
**Comments:** Paint corrosion, weed growth, moss and debris on safety surface.  
Chains showing signs of wear  
( See Appendix A)  
**Surfacing:** Wetpour

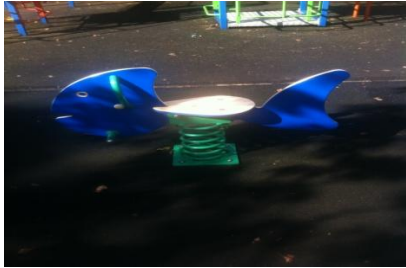
**Unit:** Play and Leisure Fish Spring Mobile  
**Year of Manufacture:** 2006  
**Overall Condition:** Good  
**Comments:** Moss and debris on safety surface.  
Clamps are showing signs of wear  
monitor until next inspection  
(See Appendix A)

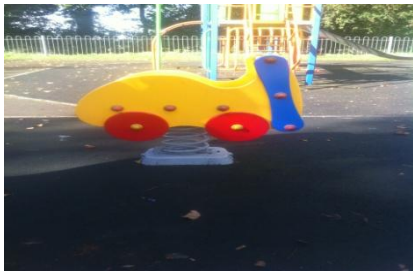
**Unit:** Ledon Car Spring Mobile  
**Year of Manufacture:** 2002  
**Overall Condition:** Good  
**Comments:** Moss and debris on safety surface  
(See Appendix A)

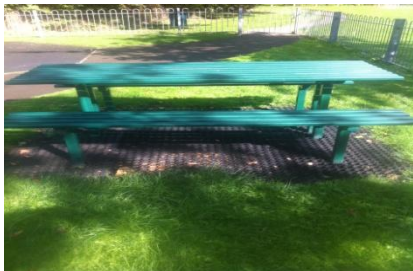
**Unit:** Bench  
**Year of Manufacture:** Unknown  
**Overall Condition:** Good  
**Comments:** Weed growth under bench  
( See Appendix A)

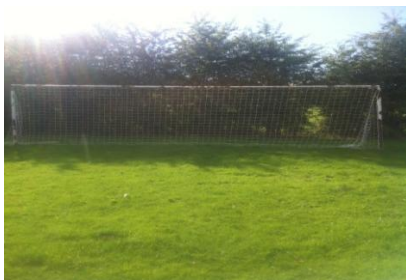
**Unit:** Goalposts  
**Year of Manufacture:** Unknown  
**Overall Condition:** Average  
**Comments:** Both goals slightly loose in ground, mole hills in area.  
Re secure the clips as the net is not attached  
(See Appendix A)

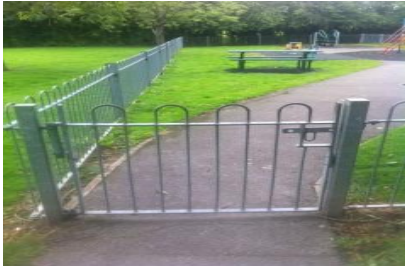
**Unit:** Fencing and Gates  
**Year of Manufacture:** Unknown  
**Overall condition:** Average  
**Comments:** Drop Pin Missing on Vehicle Access Gate  
 1 no post loose in ground, moss on fence  
 and pedestrian gate.  
**(See Appendix A)**

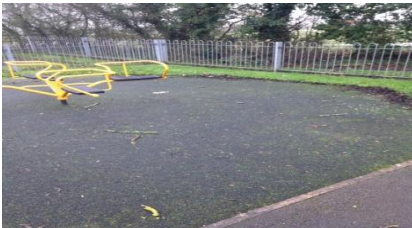
**Whirly Bird**

**Comments:**  
 Weed growth and moss and debris on area

**Recommendation:**  
 Remove weeds, moss and debris

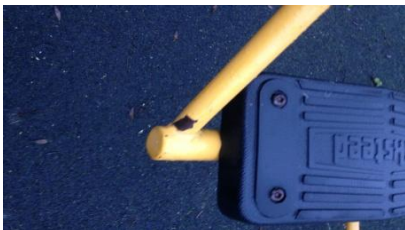
**Comments:**  
 Paintwork showing signs of wear

**Recommendation:**  
 Monitor until next inspection

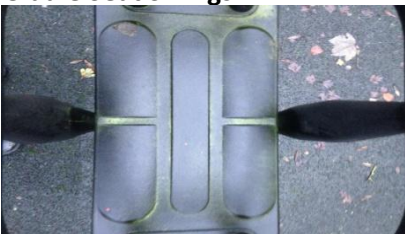
**Cradle Seat Swings**

**Comments:**  
 Moss on seats and bushes require lubricating

**Recommendation:**  
 Remove moss and lubricate bushes

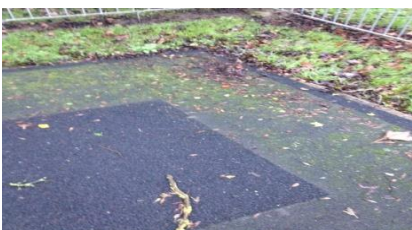
**Comments:**  
 Moss and debris on area

**Recommendation:**  
 Remove moss and debris

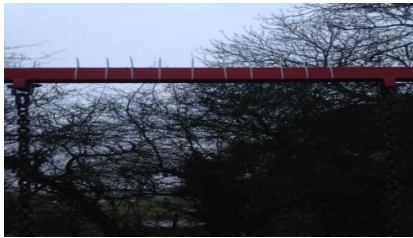
Cable ties do not comply with BS EN1176 standards

Monitor cable ties for any sharp edges

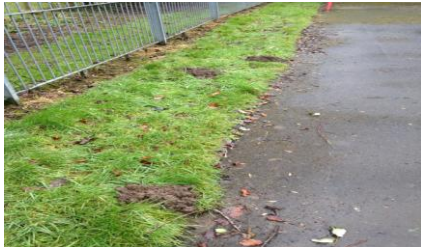
Mole hills

remove mole hills as they are a trip hazard

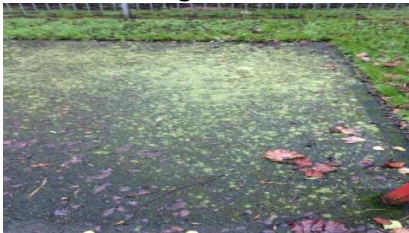
**Flat Seat Swings**

Moss and debris on area and bushes require lubricating.

Remove moss and debris and lubricate bushes

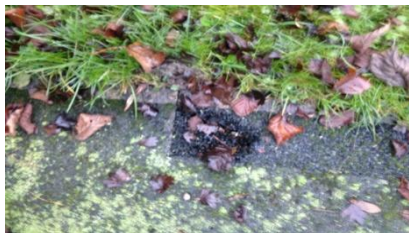
**Multi Pondo**

Damage to safety surface

Monitor safety surface until next inspection

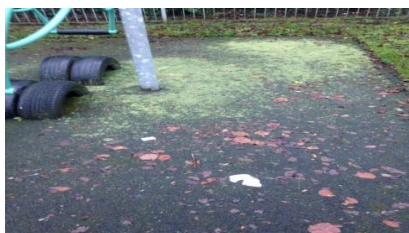
Moss and debris on safety surface

Remove moss and debris

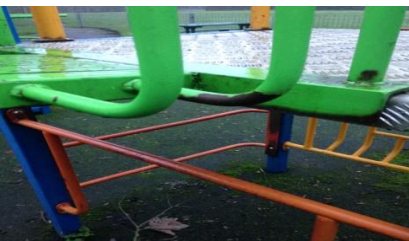
**Multi Unit**

Paint corrosion

Sand down and re-paint that complies with EN1176.4.1.1 standard.

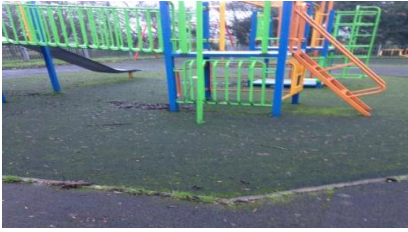
Weed growth, moss and debris on safety surface

Remove weeds, moss and debris

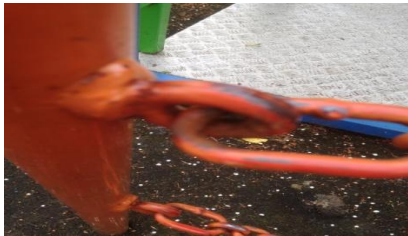
Chains showing signs of wear

Monitor chains until next inspection

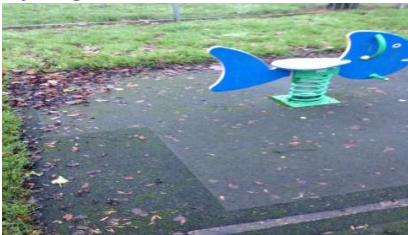
**Springers**

Moss and debris in springers safety surface

Remove moss and debris

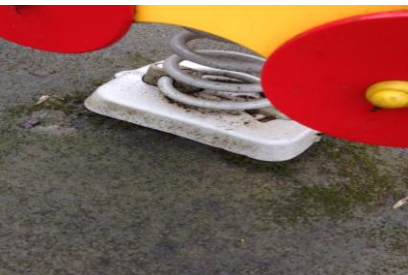
Clamps showing signs of wear

Monitor the clamps until the next inspection

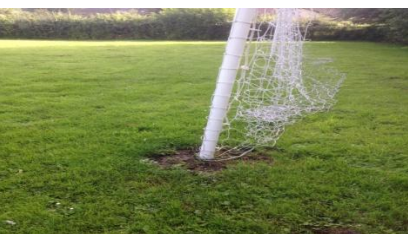
**Goal Posts**

2no goal post slightly loose in ground

Monitor goals until next inspection

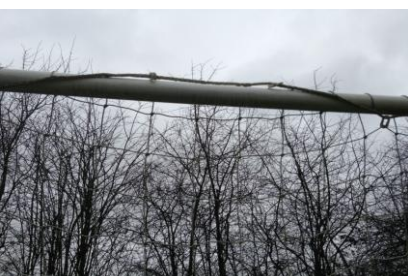
the net is not attached

Secure the net

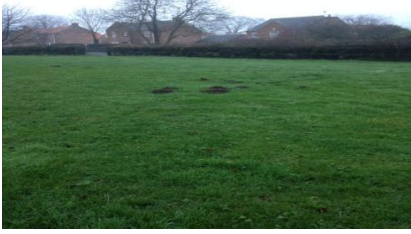
Mole hills in area

Remove mole hills

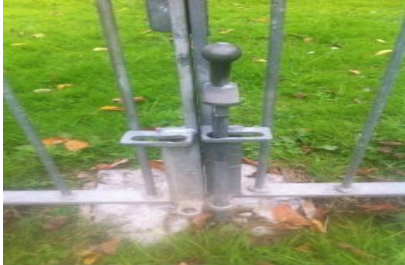
Drop pin missing on vehicular Access Gate

Replace Drop pin

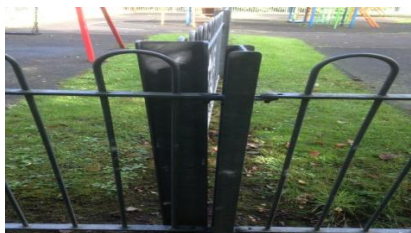
1 no post loose in ground

Secure loose post

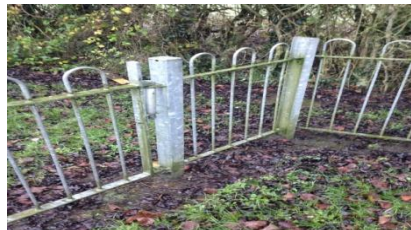
Moss on pedestrian gate and fencing

Remove moss from fencing and gate
