Staveley and Copgrove P C

Play Area Inspection

Inspected by Park Lane Playgrounds

4th March 2019 at 12.20am

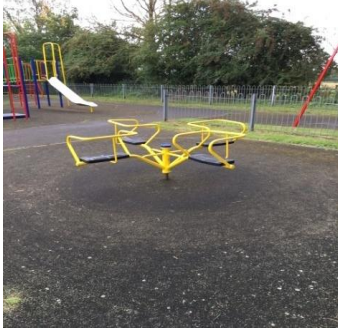
Unit: Wicksteed Whirly Bird
Year of Manufacture: 2000
Overall Condition: Good
Comments: Wet pour surface showing signs of wear

Wet pour showing signs of wear

Monitor the wet pour until the next inspection

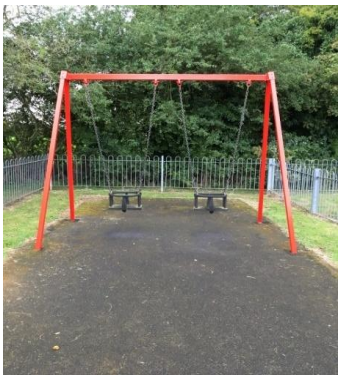
Unit: Record Cradle Swings
Year of Manufacture: Unknown
Overall Condition: Good
Comments: Grease the unit

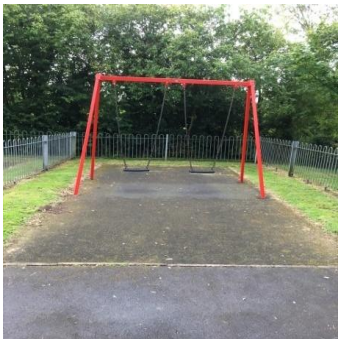
Unit: Record Flat Seat Swings
Year of Manufacture: Unknown
Overall Condition: Good
Comments:

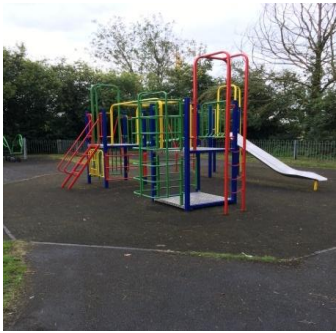
Unit: Play and Leisure Multi Unit
Year of Manufacture: 2000
Overall Condition: Good
Comments: Chains showing signs of wear

Chains showing signs of wear

Monitor chains until next inspection

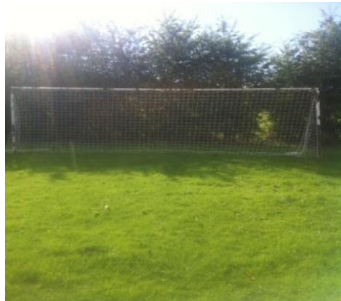
Comments: Moles hills and traps on the area
Grass requires cutting

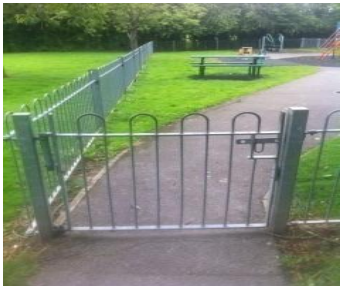
Comments: Drop Pin Missing on Vehicle Access Gate
No padlock on the vehicle access gate

Drop pin missing on vehicular Access Gate

No Padlock

Replace Drop pin

Replace the padlock
