Staveley and Copgrove P C

Play Area Inspection

Inspected by Park Lane Playgrounds

9th September 2019 at 9.55am

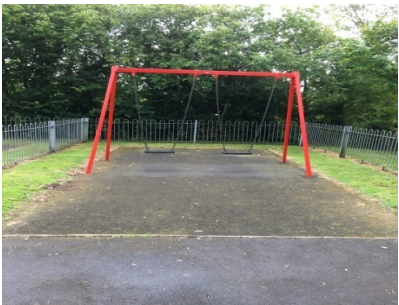
Unit: Record Flat Seat Swings
Year of Manufacture: Unknown
Overall Condition: Good
Comments: Chains wearing monitor this until the next inspection
Debris and mole hills

Slight wear on the chains

Monitor the chains until
the next inspection

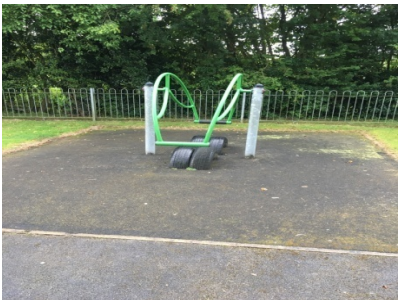
Unit: Hags Multi Pondo
Year of Manufacture: 2000
Overall Condition: Good
Comments: 2no footrests missing

Comments:
Both footrest missing

Recommendations:
Replace the rubber

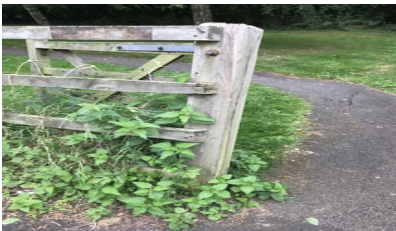
Road side gate

Both the gate posts are rotten

Replace 2no timber gate posts
