Staveley and Copgrove P C

Play Area Inspection

Inspected by Park Lane Playgrounds

4th March 2020 at 9.30am

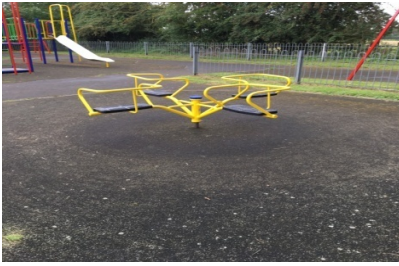
Wicksteed Whirly Bird

Year of Manufacture: 2000
Overall Condition: Good
Comments: Wet pour surface showing signs of wear

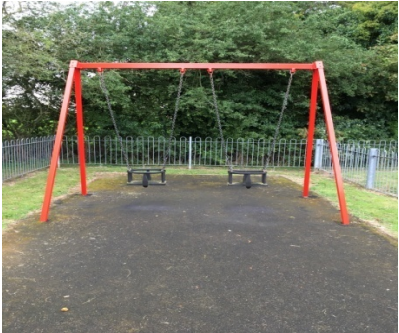
Unit: Record Cradle Swings
Year of Manufacture: Unknown
Overall Condition: Good
Comments: Grease the unit
Chains showing signs of wear
debris on the area
wetpour surface has sunk

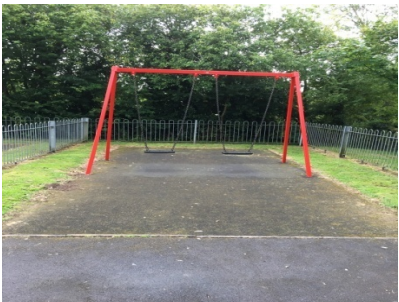
Unit: Record Flat Seat Swings
Year of Manufacture: Unknown
Overall Condition: Good
Comments: Chains wearing monitor this until the next inspection
Debris and mole hills

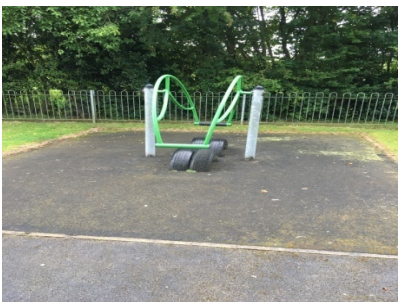
Unit: Hags Multi Pondo
Year of Manufacture: 2000
Overall Condition: Good
Comments: 2no footrests missing

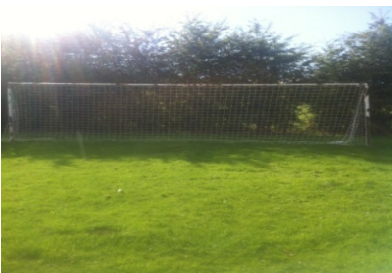
Comments: Mole hills on the field

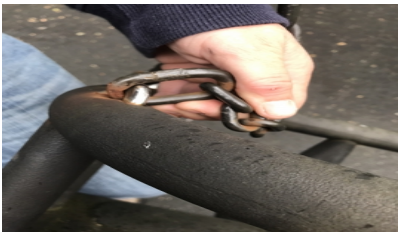
Cradle seats

Chains showing signs of wear

monitor the chain until the next
Inspection

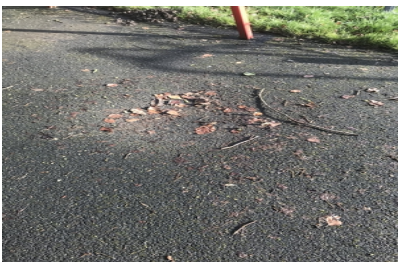
Wetpour surface has sunk

Monitor the wetpour surface until
the next inspection

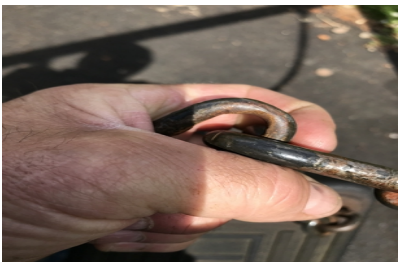
Flat seat swings

Slight wear on the chains

Monitor the chains until
the next inspection

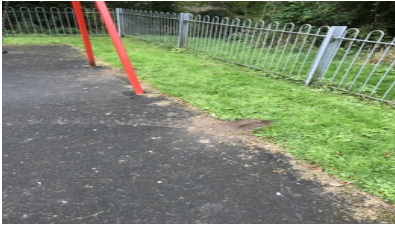
Comments:
Grass encroaching and mole hills on the surface

Recommendations:
Remove the grass and mole hills to prolong the life of the surface

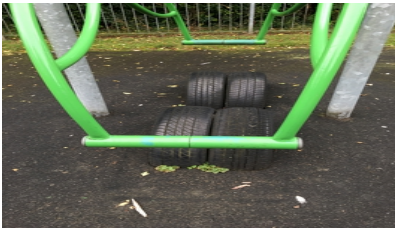
Multi pondo

Comments:
Both footrest missing

Recommendations:
Replace the rubber

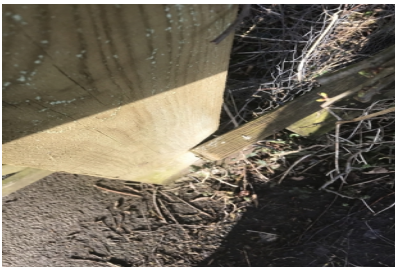
Fence rail not secure, protruding nail

Secure the fence rail, remove old nail

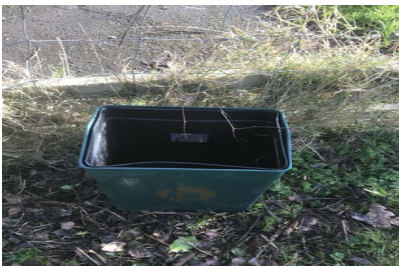
Bin is not secure

Secure the bin

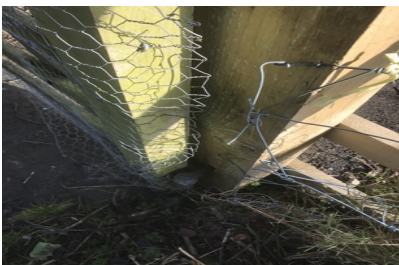
Very sharp edges on the pig netting

We would recommend using chain link fencing

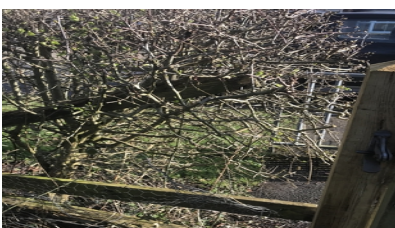
Broken rail

Replace the rail or remove from site

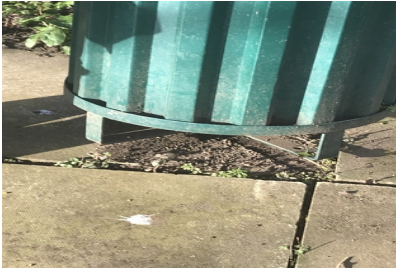
Bin Leading to the park

The bin is not secure

Secure the bin

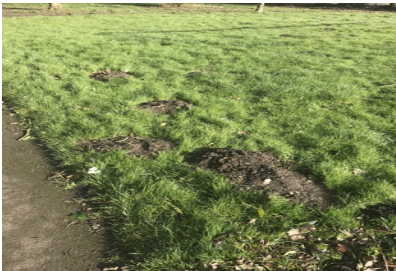
Mole hills on the football pitch

Remove the mole hills as they are a trip hazard
