Staveley and Copgrove P C

Play Area Inspection

Inspected by Park Lane Playgrounds

5th June 2020 at 11.30am

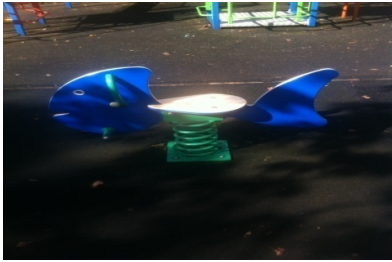
Unit: Play and Leisure Fish Spring Mobile
Year of Manufacture: 2006
Overall Condition: Good
Comments:

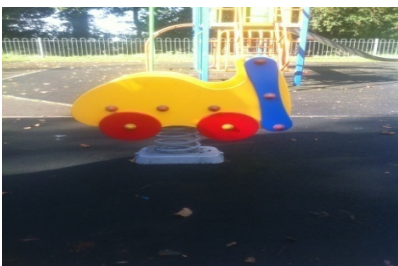
Unit: Ledon Car Spring Mobile
Year of Manufacture: 2002
Overall Condition: Good
Comments:

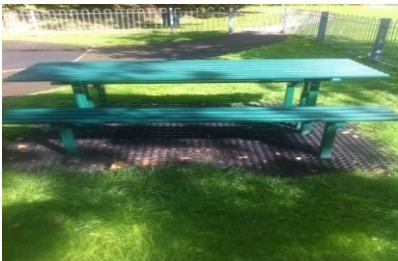
Unit: Bench
Year of Manufacture: Unknown
Overall Condition: Good
Comments:

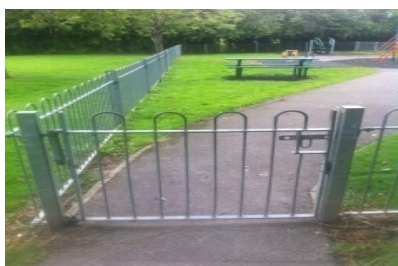
Unit: Fencing and Gates
Year of Manufacture: Unknown
Overall condition: Average
Comments: Drop Pin Missing on Vehicle Access Gate
No padlock on the vehicle access gate

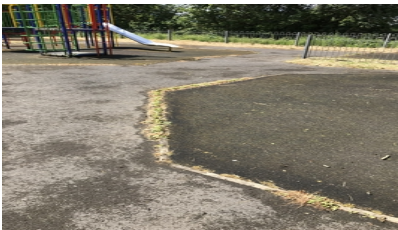
Weeds on the area

Remove the weeds to prolong the life of the wet pour surface

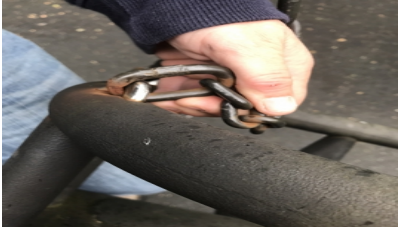
Cradle seats

Chains showing signs of wear

monitor the chain until the next inspection

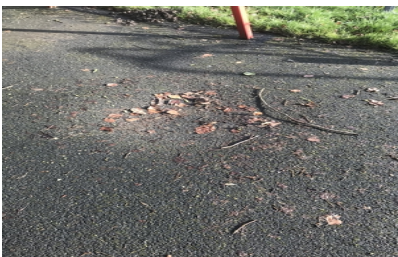
Wetpour surface has sunk

Monitor the wetpour surface until the next inspection

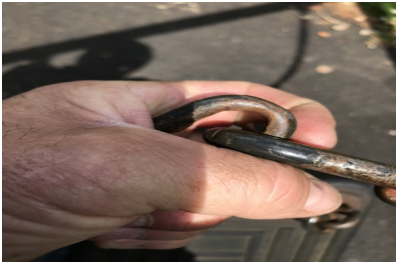
Flat seat swings

Comments:
Slight wear on the chains

Recommendations:
Monitor the chains until the next inspection

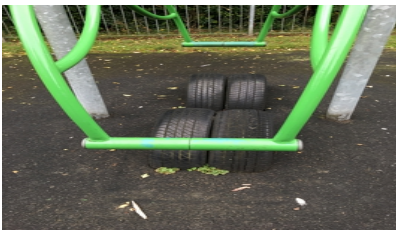
Multi pondo

Comments:
Both footrest missing

Recommendations:
Replace the rubber

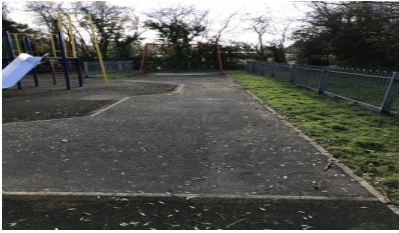
Area

Debris and weeds on the area

Remove all debris from the area, clear the site from moss and grass

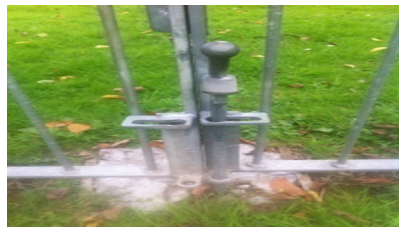
Fencing and Gates

Drop pin missing on vehicular Access Gate
No Padlock

Replace Drop pin
Replace the padlock

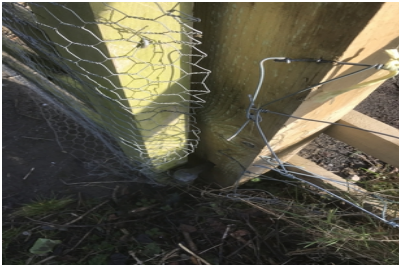
Very sharp edges on the pig netting

We would recommend using chain link fencing

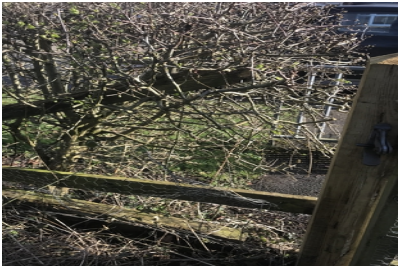
Broken rail

Replace the rail or remove from site

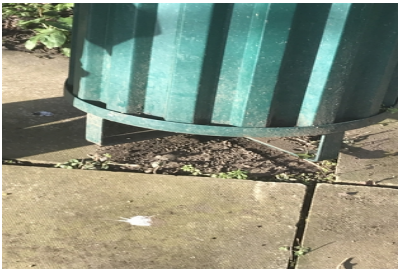
Bin Leading to the park

The bin is not secure

Secure the bin

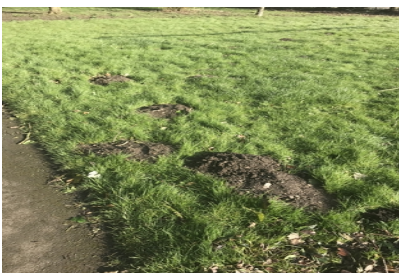
Mole hills on the football pitch

Remove the mole hills as they are a trip hazard
