# PLAY AREA SAFETY INSPECTION REPORT

Site Owner : **Parish Councils**  
Site Name : Staveley Play Area  
Date of Inspection : 22 September 2017  
Inspected by : David Owen

The present overall risk rating for the play space is **MEDIUM**

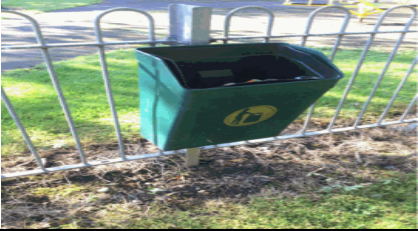
Item	Type	Comments, action or control required	Risk Level	Risk Score†
<b>Facilities</b>				
Litter Bin  Risk Score : 2 Risk Level : Very Low	Bins	Satisfactory

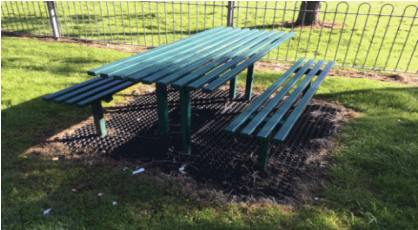
Seating - Picnic Table  Risk Score : 3 Risk Level : Very Low	Seating	Satisfactory

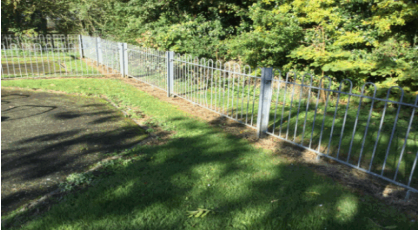
<b>Perimeter</b>				
Fencing - Bow-Top  Risk Score : 3 Risk Level : Very Low	Fencing	Satisfactory

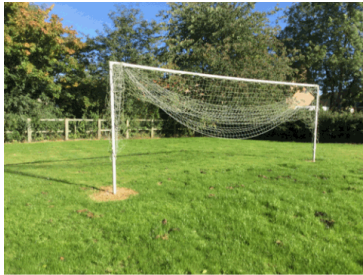
**Goal Posts x 2**

Risk Level : Medium

Risk Score : 8

The item fails to meet the requirement of the relevant standard.

Comments, action or control required		Risk Level	Risk Score ‡
<b>Equipment</b>			
Finding :	Item - Loose in Ground	Low	5
Notes :	Foundations loose on both goals - reset.

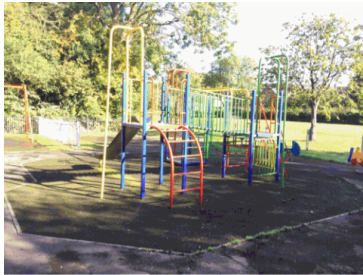
**Multiplay - Junior - With Slide**

Risk Level : Low

Risk Score : 5

The item fails to meet the requirement of the relevant standard.

The surface fails to meet the requirement of the relevant standard.

Task :	Repair item		
Finding :	The spacing between the barrier bars is in excess of 89 mm	Very Low	3
Finding Date :	22/09/2017		
Notes :	Between barriers on slide, step, overhead and arch access points.

<p>Task : The protective surface under all bars and rings must be kept in good condition.</p>	<p>Low</p>	<p>5</p>
<p><b>Surfacing - Wet Pour</b></p>		
<p>Finding : Surface - Moss</p> <p>Notes : Slippery surface - clean surface regularly due to trees.</p>

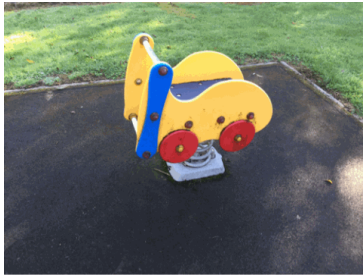
**Rocker - Car**

Risk Level : Very Low

Risk Score : 3

The surface fails to meet the requirement of the relevant standard.

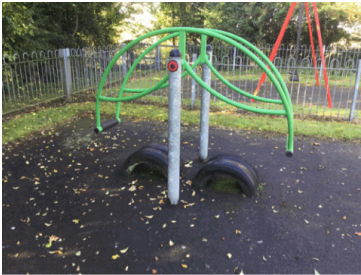
**Rocker - Seesaw - Multipondo**

Risk Level : Low

Risk Score : 5

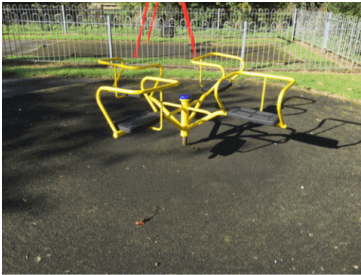
**Roundabout - Whirlybird**

Risk Level : Low

Risk Score : 5

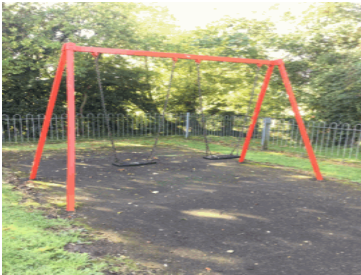
**Swing - Junior - 1 Bay 2 Seat**

Risk Level : Low

Risk Score : 4

Comments, action or control required		Risk Level	Risk Score ‡
<b>Equipment</b>			
<p>Finding : Bird fouling present</p> <p>Finding Date : 22/09/2017</p> <p>Notes : Children will not be able to use the swing in this condition. Our inspector recommends you install anti-bird ties to the top bar.</p>

<p>Task : It is recommended that play equipment is regularly checked for bird fouling- If found the affected items should be cleaned with a disinfectant solution</p>	Medium	8	
<b>Surfacing - Wet Pour</b>			
<p>Finding : Surface - Moss</p> <p>Finding Date : 22/09/2017</p> <p>Notes : Slippery surface - clean surface regularly due to trees.</p>

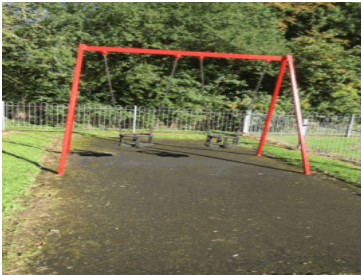
**Swing - Toddler - 1 Bay 2 Seat**

Risk Level : Very Low

Risk Score : 3
