Staveley and Copgrove P C

Play Area Inspection

Inspected by Park Lane Playgrounds

5th June 2020 at 11.30am

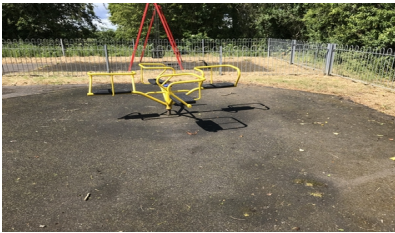
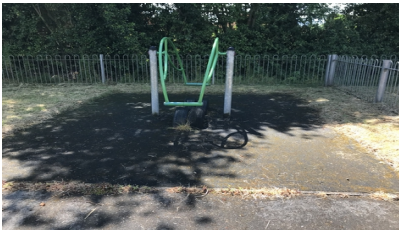
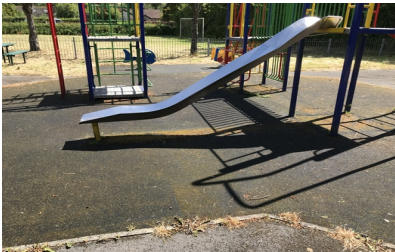
Area

Comments:

Debris and weeds on the area

Recommendations:

Remove all debris from the area, clear the site from moss and grass

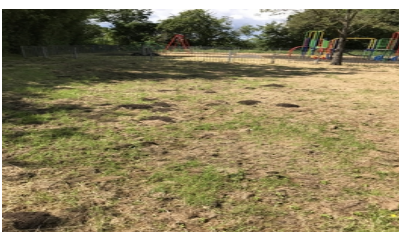
Comments:

Recommendations:

Remove the mole hills as they are a trip hazard
